# *Structural Assessment Report*

*CO25/123/08*

*Holy Trinity Church*

*Hartshill*

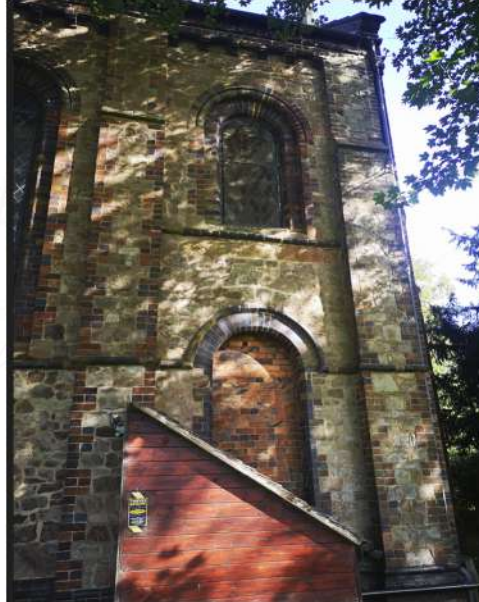
- 4.1 On the south elevation, above the basement doorway, diagonal cracks have reappeared in the area previously repaired. JMS were informed that earlier crack repairs were carried out using the Helifix crack stitching method. Refer to Photos 1 and 2.
- 4.2 Diagonal cracks are observed on the south side of the basement staircase core. The cracking is more severe at the upper level than at the lower level. Refer to Photo 3.
- 4.3 Diagonal cracks are visible at the plinth level of the east elevation walls surrounding the shallow apsidal chancel. Refer to Photo 4.
- 4.4 Vertical crack is present at the lintel level of one of the windows on the north elevation. Refer to Photo 5.

*Image 1 – Helifix crack repairs carried out in the past*

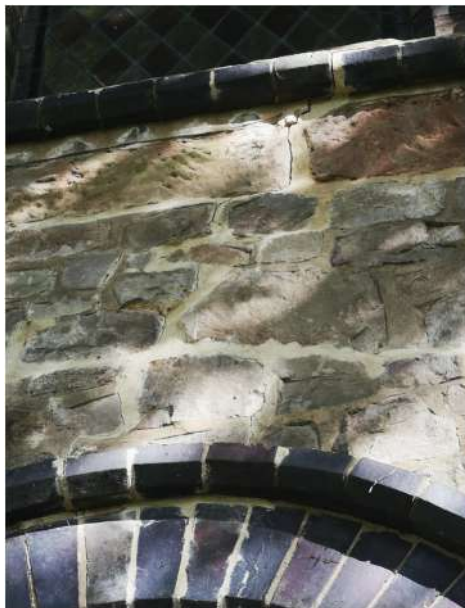
*Image 2 – Diagonal cracks above window -within the helifix repair*

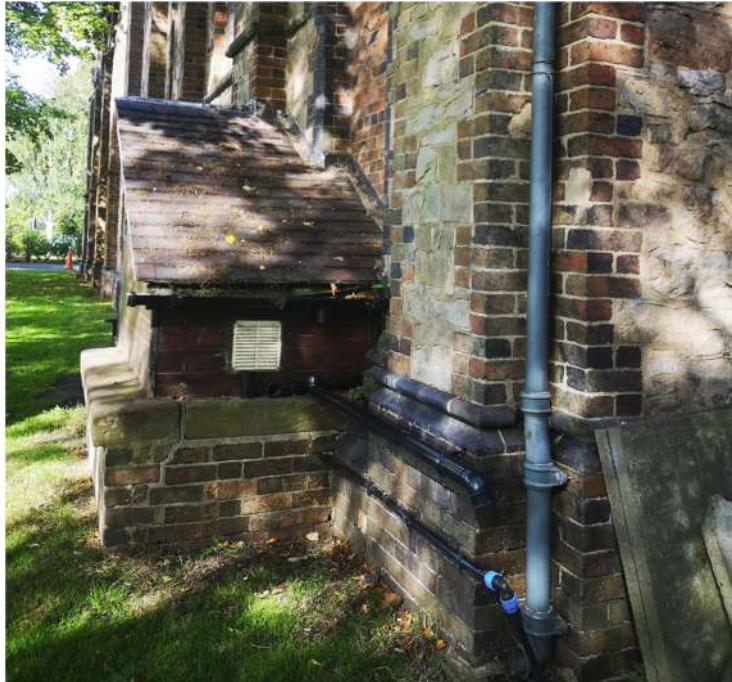
*Image 3 – Diagonal cracks in basement staircore*

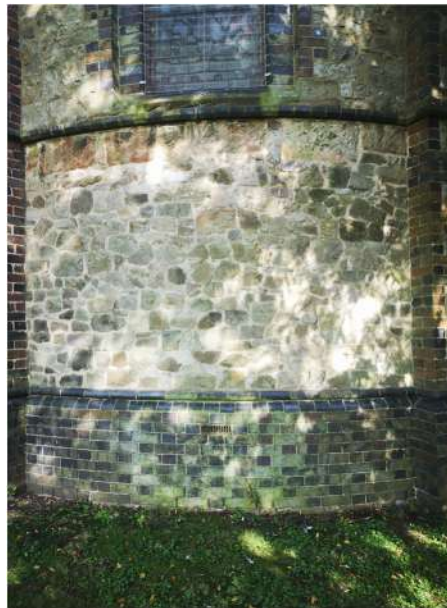
*Image 4 – Diagonal crack in the rear elevation*

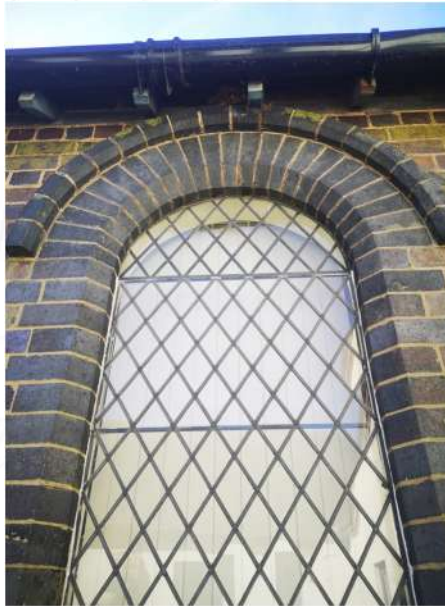
*Image 5 – Cracked joint at brick lintel to the side elevation*

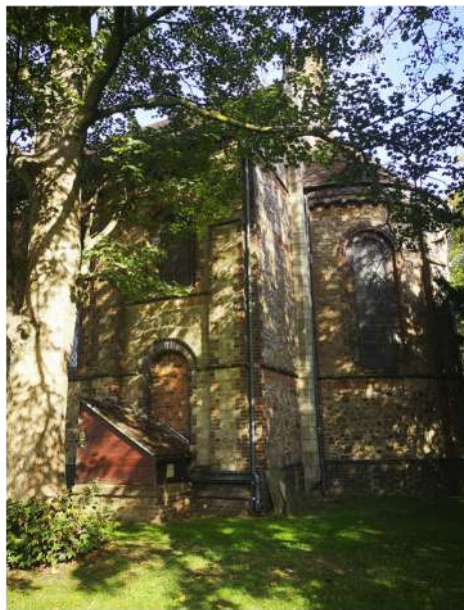
- 5.2 *It is suspected that settlement of the South elevation and east elevation wall foundation has caused outward rotation of the building, resulting in major structural cracks at the south east side of the building. This movement may be due to consolidation of the underlying clayey soils, potentially combined with shrinkage caused by roots from the nearby trees. In particular, the proximity of the trees located at the south-east corner and south west corner of the building is likely contributing to the soil shrinkage. Refer to photos 6.1 & 6.2.*

*Image 6.1 – Proximity of sycamore tree to the South East corner*

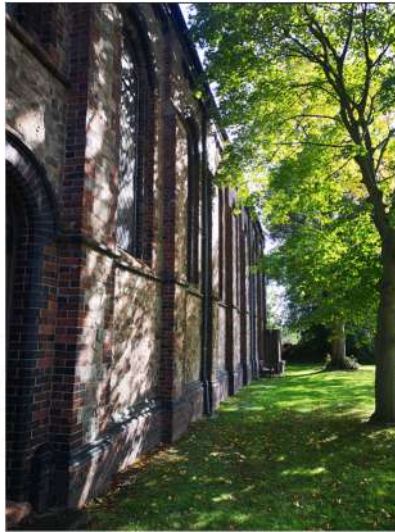
*Image 6.2 – South elevation showing adjacent trees*

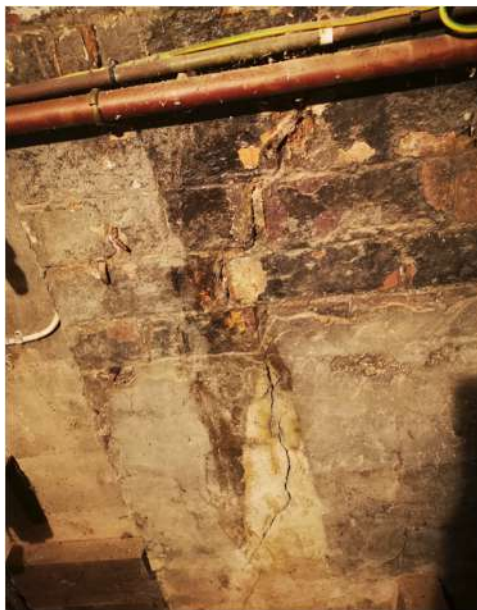
- 4.5 *Multiple diagonal cracks are present in the east wall of the basement. The cracks are wider at higher levels, with widths ranging between 2 mm and 5 mm. Refer to Photos 7.1 and 7.2.*

*Image 7.1 – Cracked basement – East side wall*

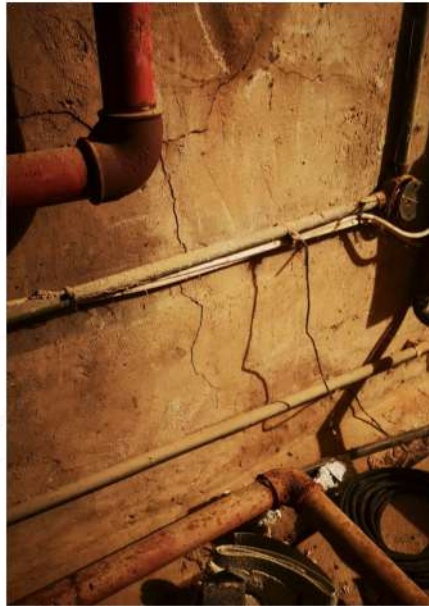
*Image 7.2 Cracked basement wall– East side*

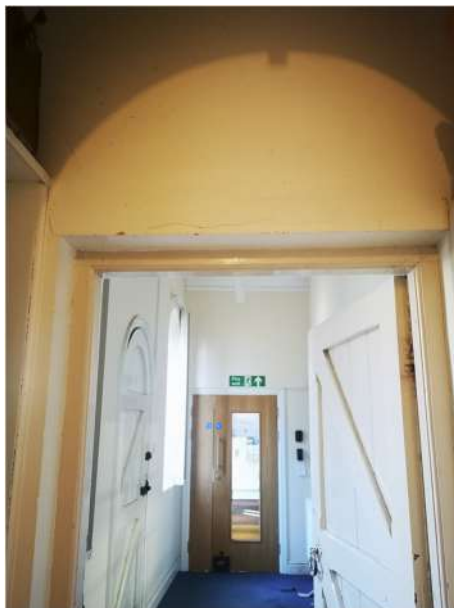
- 4.6 *Horizontal Horizontal hairline cracks are observed around the door opening between the church building and the corridor leading to the library. Refer to Photo 8.*

*Image 8 – Horizontal cracks above the door opening*

- 5.8 *For the minor internal cracks around the window openings in the north elevation wall and the north bay (refer to photos 8 to 11), the existing plaster should be removed to a width of 75mm on each side of the crack. Reinforced plaster tape should then be applied over the crack, followed by re-plastering using Carlite Renovating Plaster. The new plaster should be feathered in at the edges to blend seamlessly with the surrounding surface. If the repair works to the other walls are carried out before addressing the foundation movement, there is a risk that the cracks may reappear, potentially requiring the repairs to be redone.*

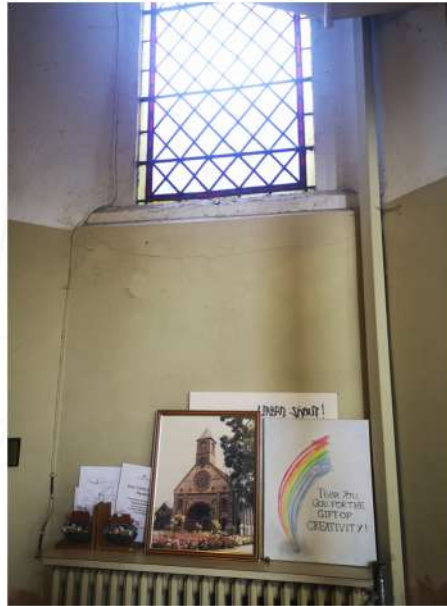
- 4.7 *Multiple hairline cracks and areas of flaking plaster are present below the front elevation window on the northern side of the bay leading to the library. Refer to Photo 9.*

*Image 9– Horizontal cracks below the front elevation window sill level*

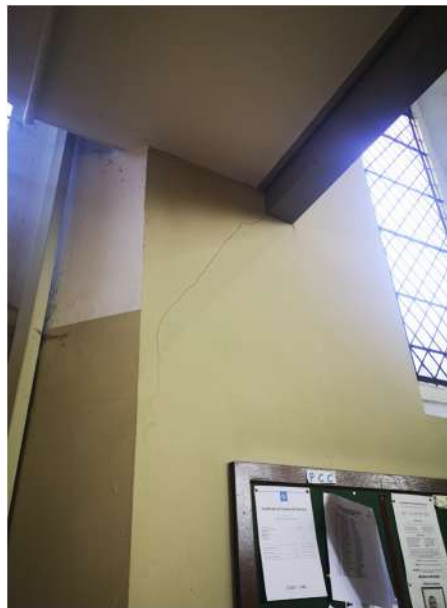
- 4.8 *A diagonal crack is visible below the timber beam supporting the mezzanine floor, where it bears on the north elevation wall. Refer to Photo 10.*

*Image 10– Diagonal cracks below the timber beam at mezzanine level*

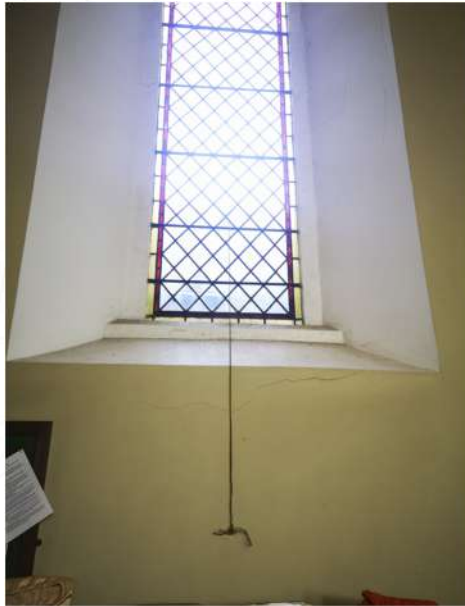
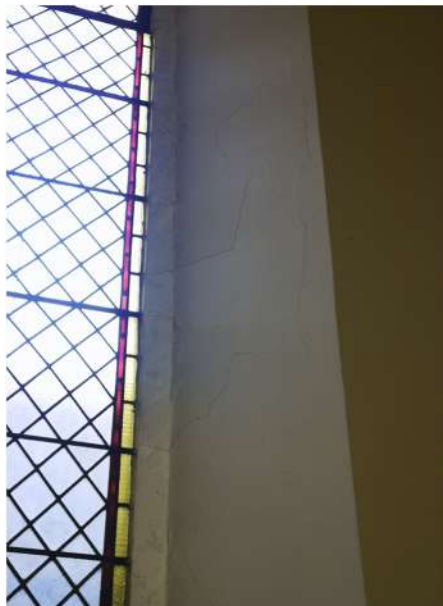
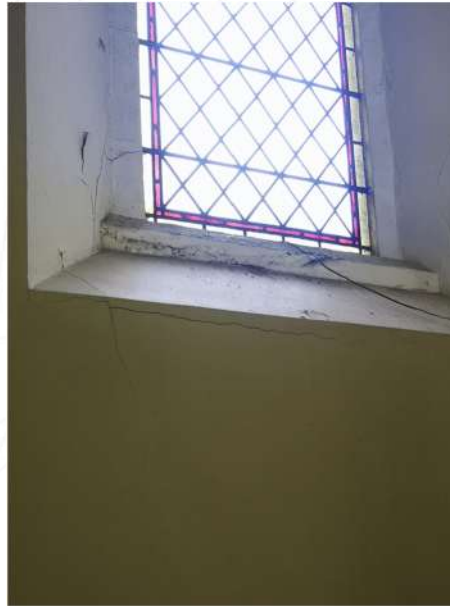
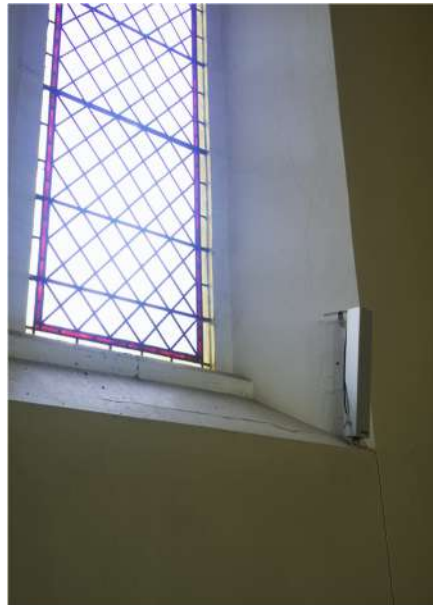
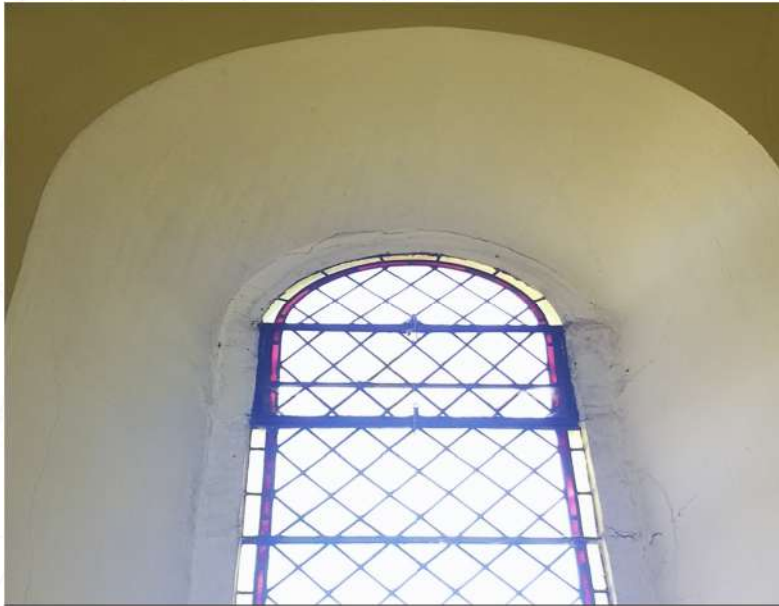
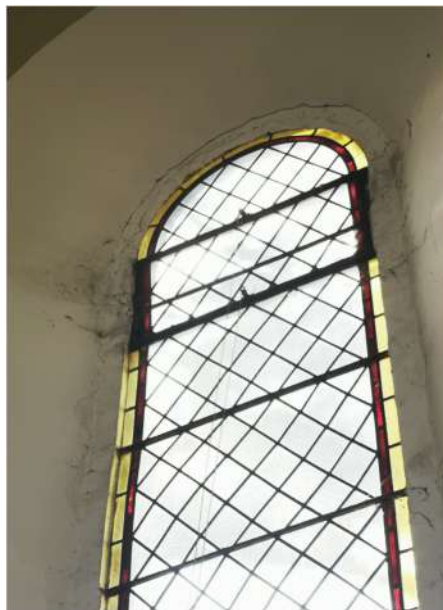
- 4.9 *Multiple hairline vertical and horizontal cracks are present around the window openings on the north and south elevation walls, along with areas of flaking plaster. The cracks are generally less than 2 mm in width. Refer to Photos 11.1 to 11.6, 12, and 13.*

- 5.3 *Multiple hairline cracks and flaking plaster around the windows are likely caused by thermal expansion and shrinkage. Seasonal temperature changes can lead to shrinkage of the lime plaster, resulting in cracking and plaster flaking.*

*Image 11.1 – Multiple hairline cracks around the window*

*Image 11.2 – Multiple hairline cracks around the window*

*Image 11.3 – Multiple hairline cracks around the window*

*Image 11.4 – Multiple hairline cracks around the window*

*Image 11.5 – Multiple hairline cracks around the window*

*Image 11.6 – Multiple hairline cracks around the window*

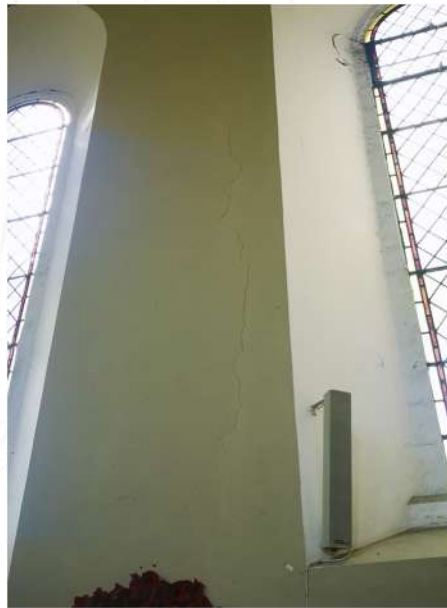
- 4.10 *A vertical crack is observed at mid-height of the wall between the windows on the north elevation, near the east end. Refer to Photo 12.*
- 4.11 *A vertical crack is visible at mid-height of the south side pier located at the start of the apse/chancel area. Refer to Photo 14.*

*Image 12 – Vertical cracks between windows*

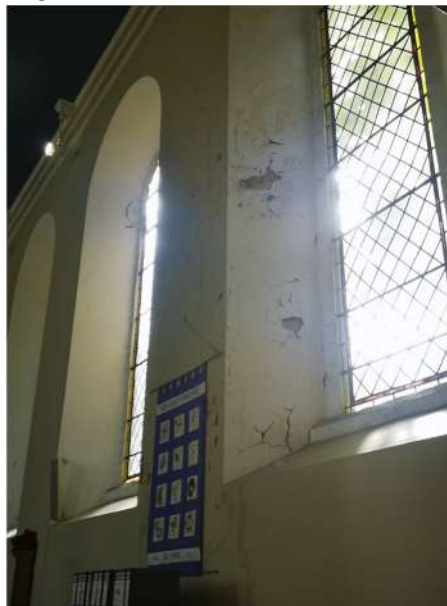
- 4.16 *The concentration of cracking and flaking plaster is notably more severe on the south elevation wall, particularly at the southeast and southwest corners where trees are located in close proximity to the building. Refer to Photos 13 to 20.*

*Image 13 – Multiple cracks and flaked plaster work in south elevation window*

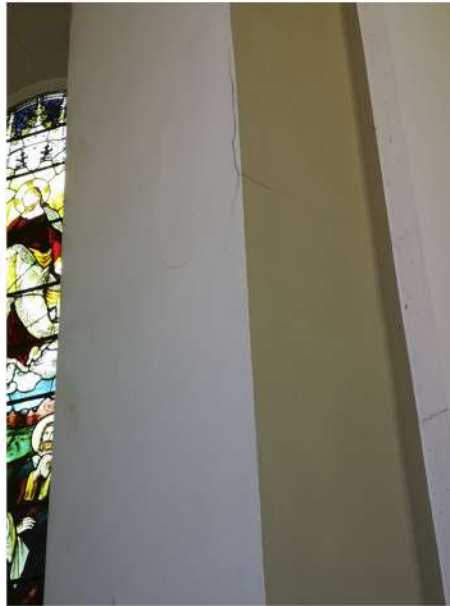
*Image 14 – Vertical cracks in the south side pier between Apse and Nave*

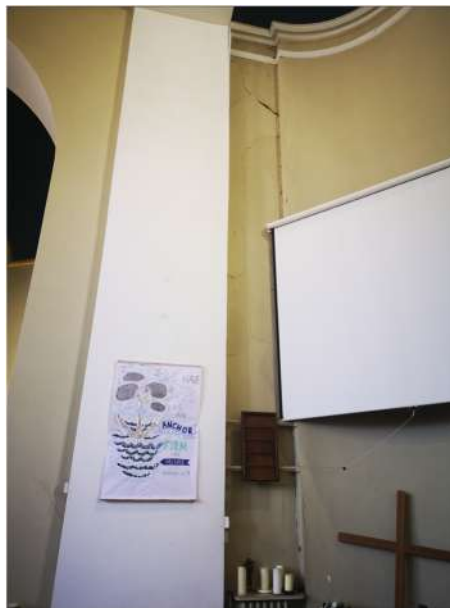
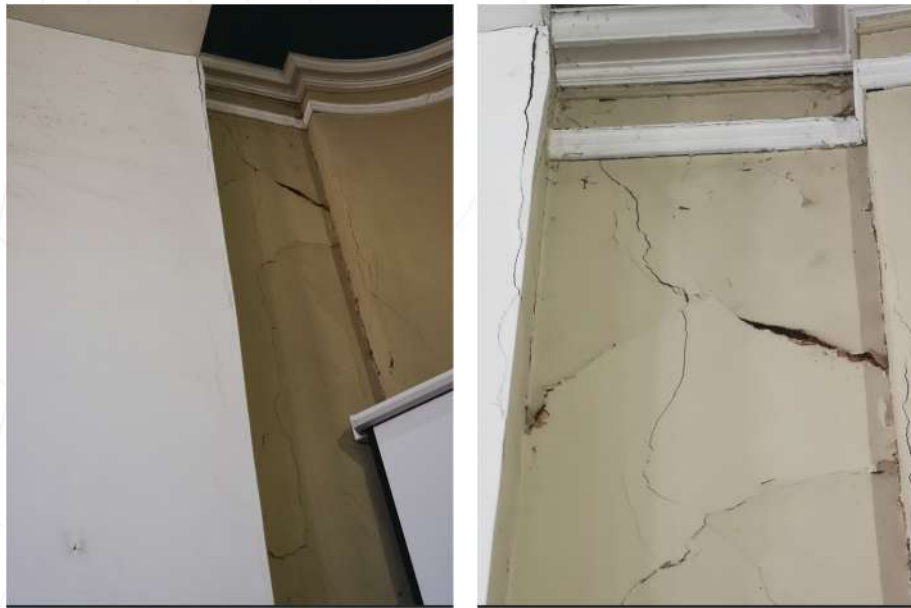
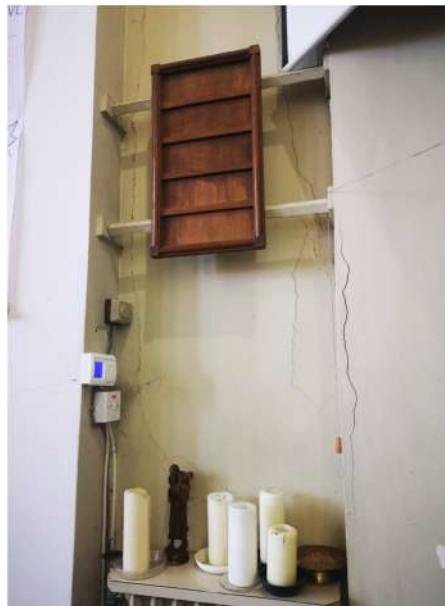
- 4.12 *Significant and widespread cracking is observed around the southeast corner of the east and south elevation walls. Vertical cracks extend the full height of the wall, with widths ranging between 12 mm and 25 mm. Refer to Photos 15.1 to 15.3.*

*Image 15.1 – Vertical cracks and flaked plaster in the rear wall*

*Image 15.2 Vertical cracks and flaked plaster south east corner wall*

*Image 15.3 Vertical cracks and flaked plaster in the rear wall*

- 5.6 *We recommend undertaking further crack width monitoring for a period of 12 months, followed up with a brick course distortion survey and trial pit investigation to get a better understanding on the cause and nature of the structural movement. For crack monitoring, it is recommended to install "tell-tales" at significant crack locations, including those in the South East corner, large wheel window and the wall between the Nave and south bay leading to staircase to monitor any further movement over time. The crack monitoring gages should be inspected and recorded periodically every 2 months for a minimum of 12 months to determine if the movement is ongoing.*

- 5.7 *Once the above monitoring is completed a suitable remedial solution can be developed and implemented. This may potentially require underpinning of the south elevation wall. Additionally, partial underpinning of the east and/or west elevations may be necessary.*

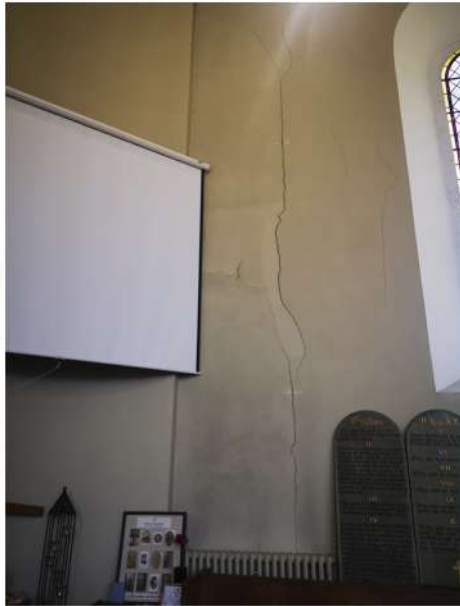
*Image 16 Full height vertical cracks in the South east corner of south elevation wall*

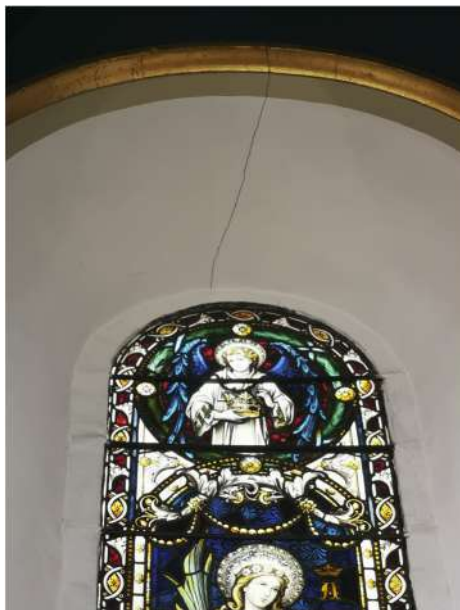
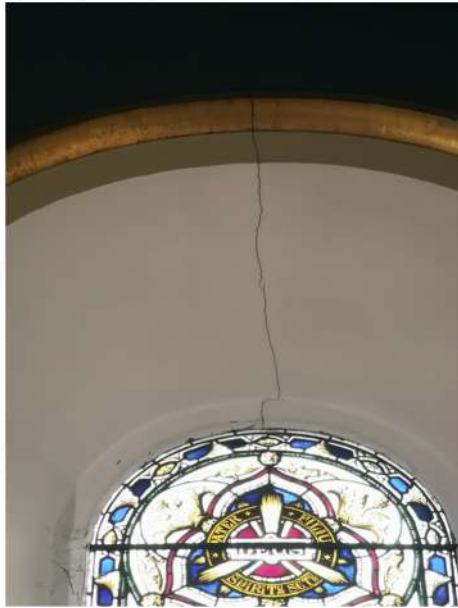
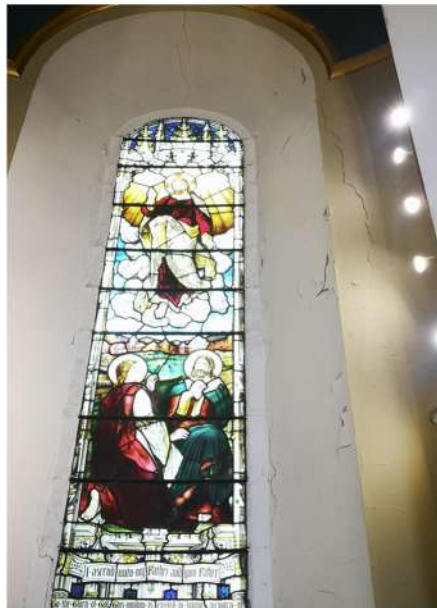
- 4.13 *Multiple hairline vertical and horizontal cracks, along with areas of flaking plaster, are present around the window openings within the apse area. Refer to Photos 17.1 to 17.3.*

*Image 17.1 Vertical cracks above window within Apse*

*Image 17.2 Vertical crack above window within Apse*

*Image 17.3 Multiple cracks around the window opening in Apse*

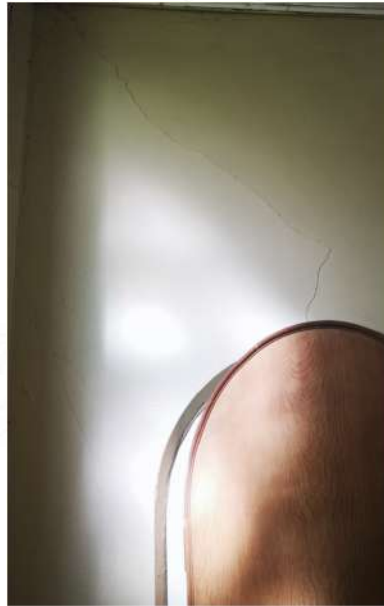
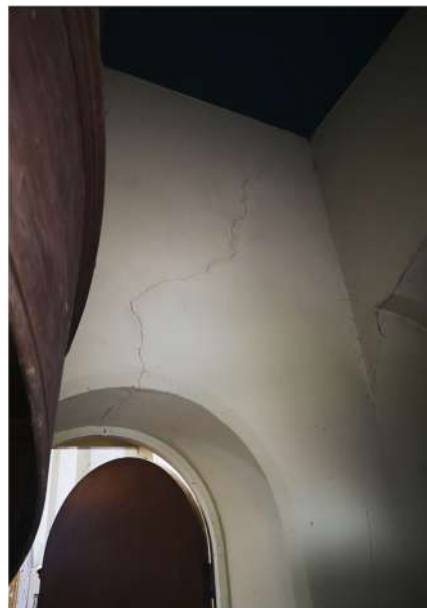
- 4.14 *Multiple diagonal and vertical cracks are observed in the wall between the south bay and the nave, with crack widths ranging from 1 mm to 2 mm. Diagonal cracks are also noted above the door opening at ground floor level in the south bay. Refer to Photos 18.1 to 18.4.*

- 5.4 *Cracks observed around the door opening in the south bay, the front elevation window in the south bay, the large wheel window, and in the basement may be attributed to foundation movement or distortion.*

*18.3 Diagonal cracks above the door opening between the south bay and the Nave*

*Image 18.4 Diagonal cracks above the door opening between the south bay and the Nave*

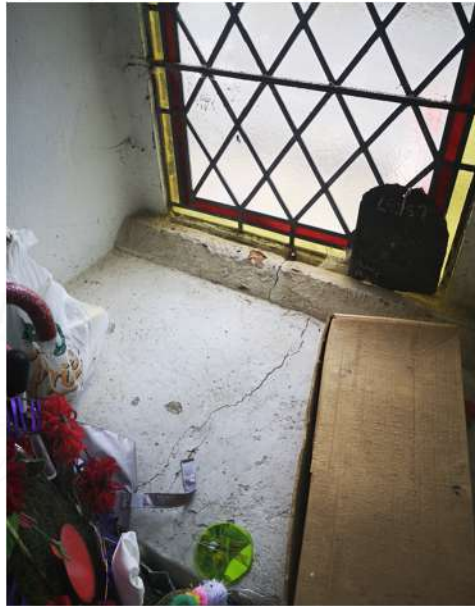
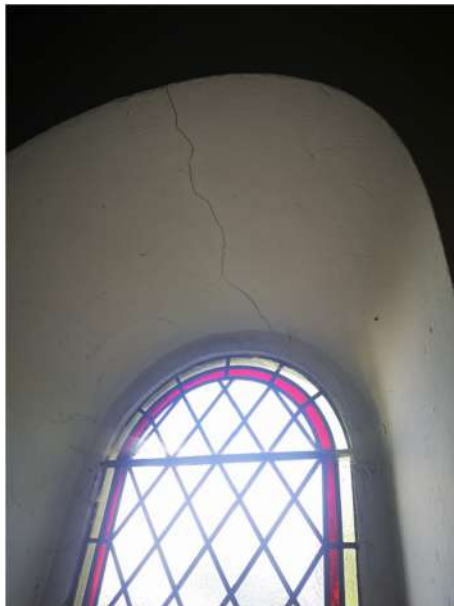
- 4.15 *Multiple vertical and diagonal cracks are observed above and below the window openings in the south bay of the front elevation wall. The cracks are generally less than 2 mm in width. Refer to Photos 19.1 and 19.2.*

*Image 19.1 Cracks around the front elevation window within the staircase room*

*Image 19.2 Cracks around the front elevation window within the staircase room*

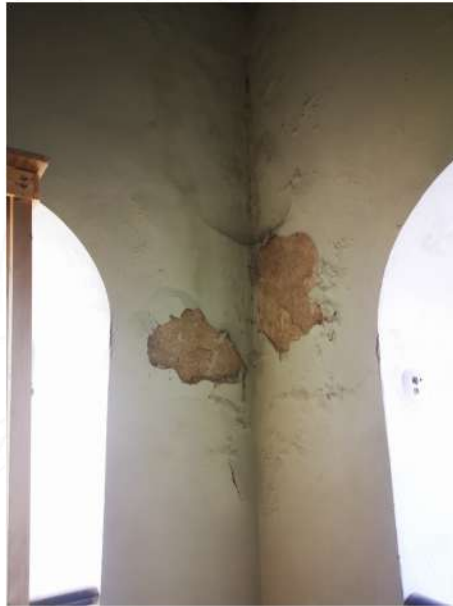
- 4.17 *Severe flaking of plaster is observed around the southwest corner of the landing area. Refer to Photo 20.*
- 4.18 *A diagonal crack is present above the door opening in the south bay, between the mezzanine floor and the staircase landing. The crack width is less than 2 mm. Refer to Photo 21.*
- 4.19 *Severe diagonal cracks are observed around the large wheel window opening on the front elevation wall, with crack widths ranging between 10 mm and 20 mm. Refer to Photos 22.1 to 22.3*

*Image 20 Flaked lime plaster at mezzanine landing level*

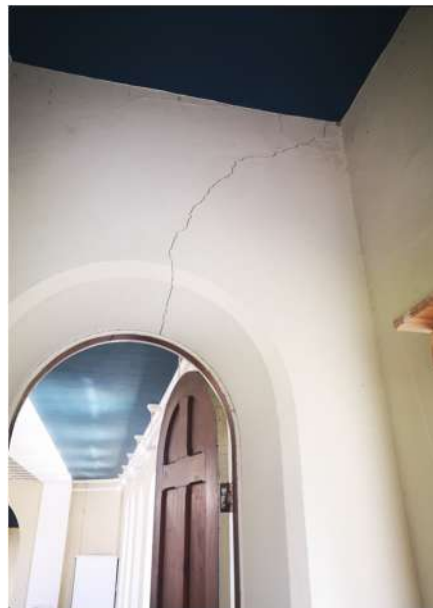
*Image 21 Diagonal cracks above door opening at mezzanine floor level*

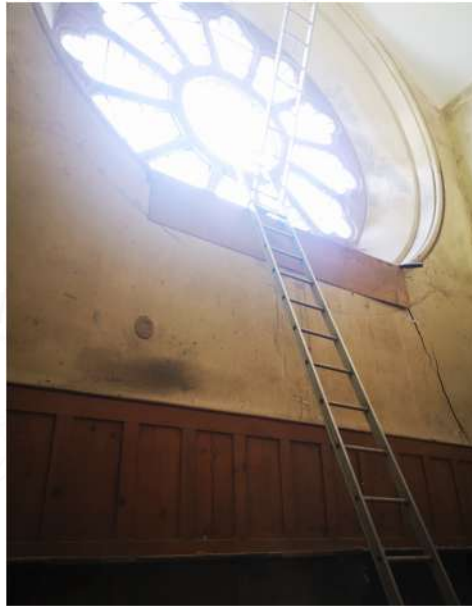
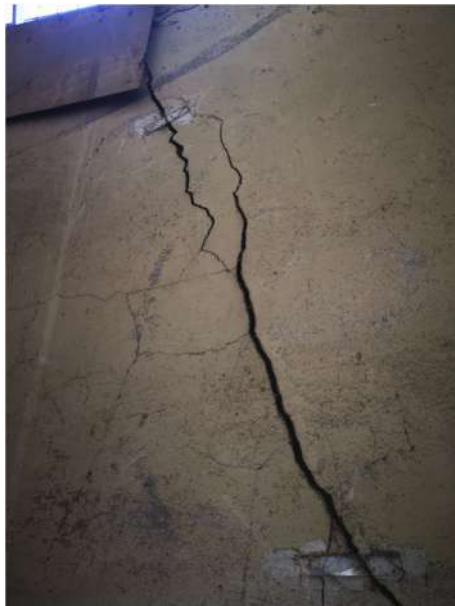
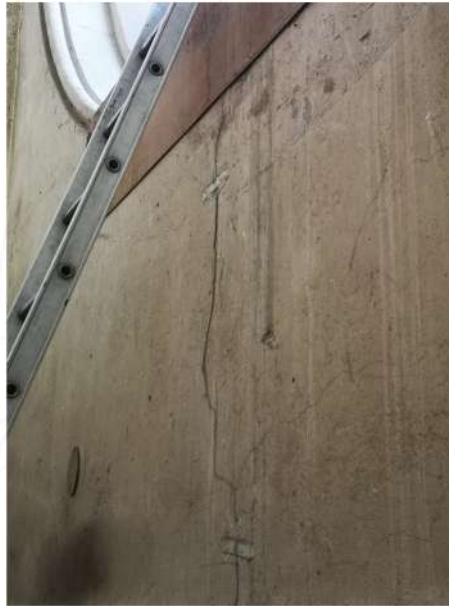
- 5.1 *The observed significant structural cracks in the south elevation wall and front elevation wall below the long wheel window appears to be longstanding and show signs of progressive widening over time.*

*Image 22.1 Diagonal cracks below the Large wheel window opening*

*Image 22.2 Diagonal cracks below the Large wheel window opening*

*Image 22.3 Diagonal cracks below the Large wheel window opening*

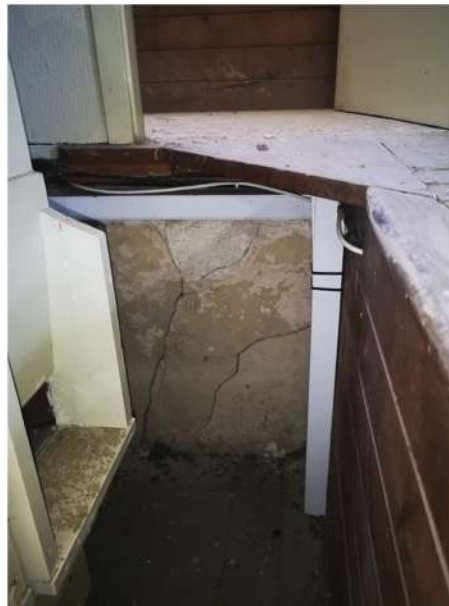
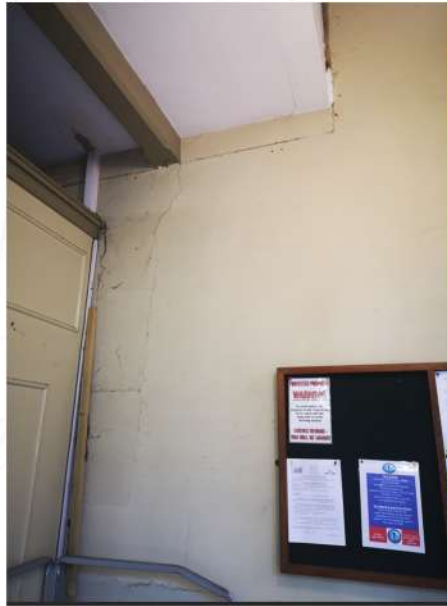
- 4.20 *Multiple diagonal cracks are observed below the door opening between the north bay and the platform leading to the large wheel window. The cracks are wider at the top and gradually narrow toward the lower levels. Refer to Photo 23.1. These cracks extend below the mezzanine floor level and appear as fine hairline cracks at ground floor level. Refer to Photo 23.2.*

*Image 23.1 Diagonal cracks at mezzanine level*

*Image 23.2 Diagonal cracks at mezzanine level extended below*

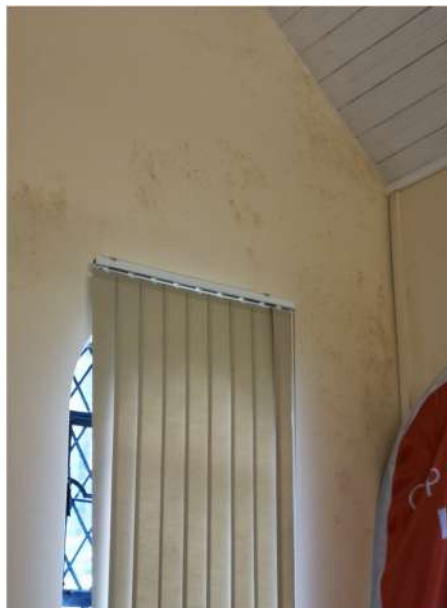
- 4.21 *Overall, the Library building is in an acceptable condition, showing only minor wear and tear consistent with its age. No cracking or signs of structural movement were observed, so no specific concerns are noted for this part of the building. However, dampness issues were observed on the east elevation wall. Refer to Photo 24.*

- 5.5 *Dampness on the east side wall of the library building may be due to a faulty gutter allowing water ingress into the masonry. We recommend regular gutter maintenance and replacement where necessary to prevent further issues.*

*Image 24 Dampness in the East side wall of Library*
