Statement of Significance- Holy Trinity Church, Hartshill

Revision 7- December 2025

Executive Summary

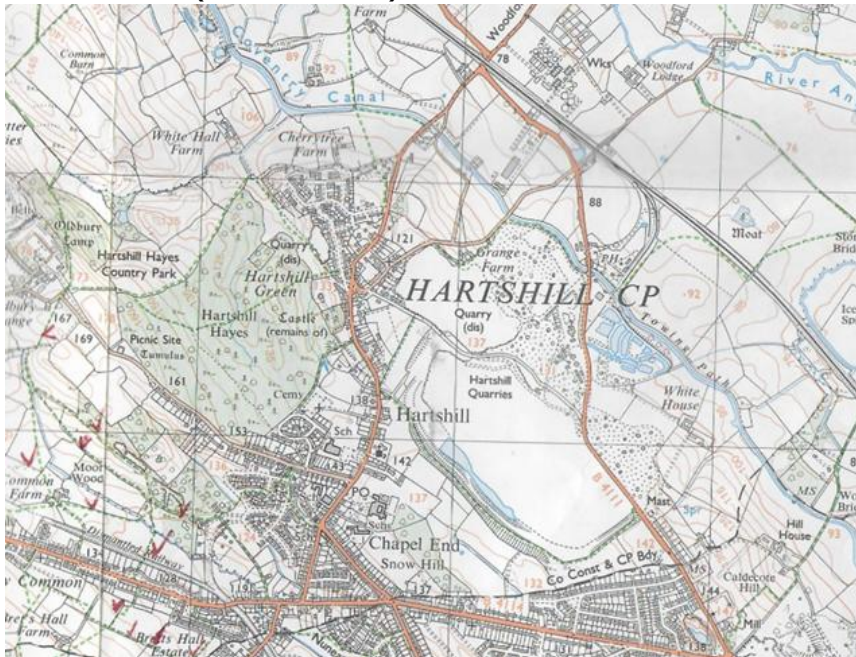
Not to Scale.

The built-up area of the village starts in the north soon after crossing over the Canal Hayes Bridge. The road rises steeply from the B4111 and is first known

as Atherstone Road which turns in Castle Road (named after the ruins of Hartshill Castle). The road flattens out along the broad ridge (which runs east/west) and becomes Church Road.

The Church is built at one of the highest points along the road.

Church Road at a crossroads becomes School Hill which slopes steeply down to link with the B1114 which links Nuneaton to Coleshill (to the west) and on to Birmingham. The B1114 in the parish is known as Coleshill Road

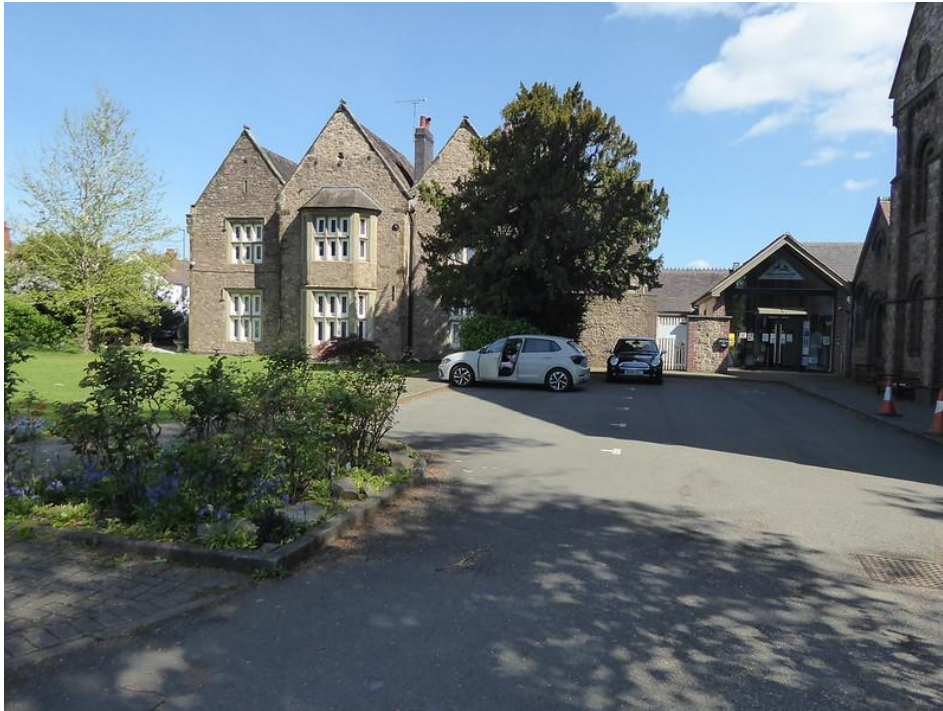
The Old Vicarage and Community Centre Entrance (on right).

On the northern boundary is the Community Centre and the Old Vicarage (now privately owned) which is built in granite stone and complements the appearance of the church building really well. Both the vicarage and the Church front onto a grass lawn.

The new build is between the vestry and the existing main hall and contains a new entrance, lobby, new toilets, new kitchen and a new meeting room. There is also a conservatory which was added later.

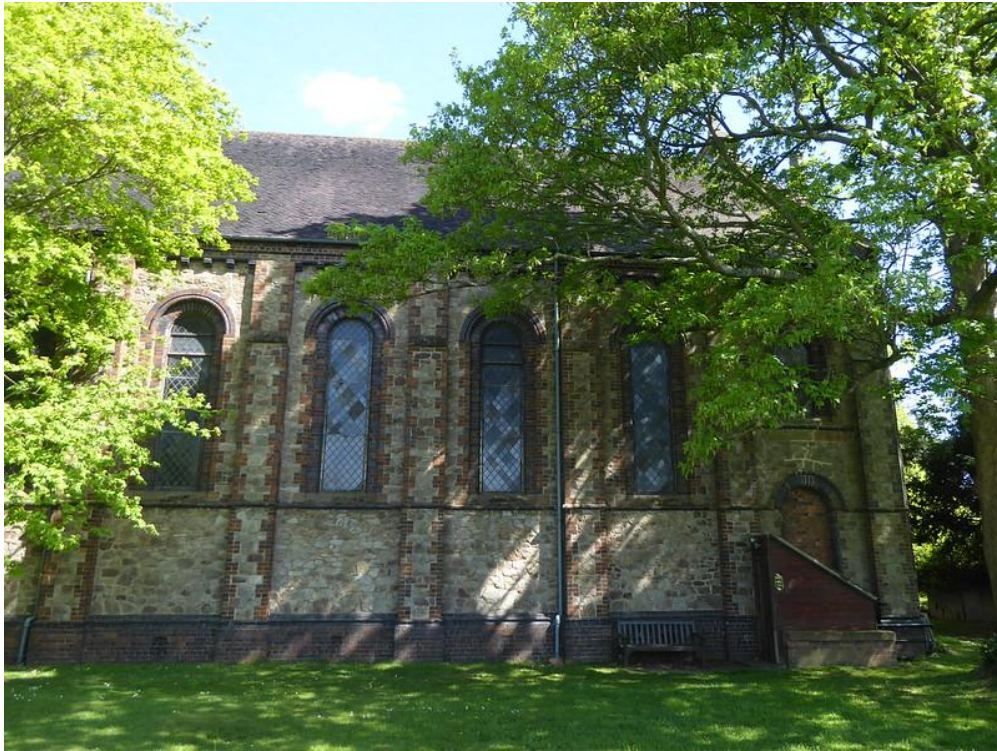
Southern elevation.

The north, south and east walls are plainer, constructed of brick quoins/piers and stone infill and the areas in between with local quarry stone. The walls have a plinth of blue bricks and blue brick string courses and corbelling. The tall but narrow lead windows have a blue brick arch course over the windows. There are two bricked up doors in the south and north elevations at the eastern end. Above those are smaller windows
In front of the bricked-up door on the southern elevation is a wooden sided porch in front of the boiler house which is below ground level.

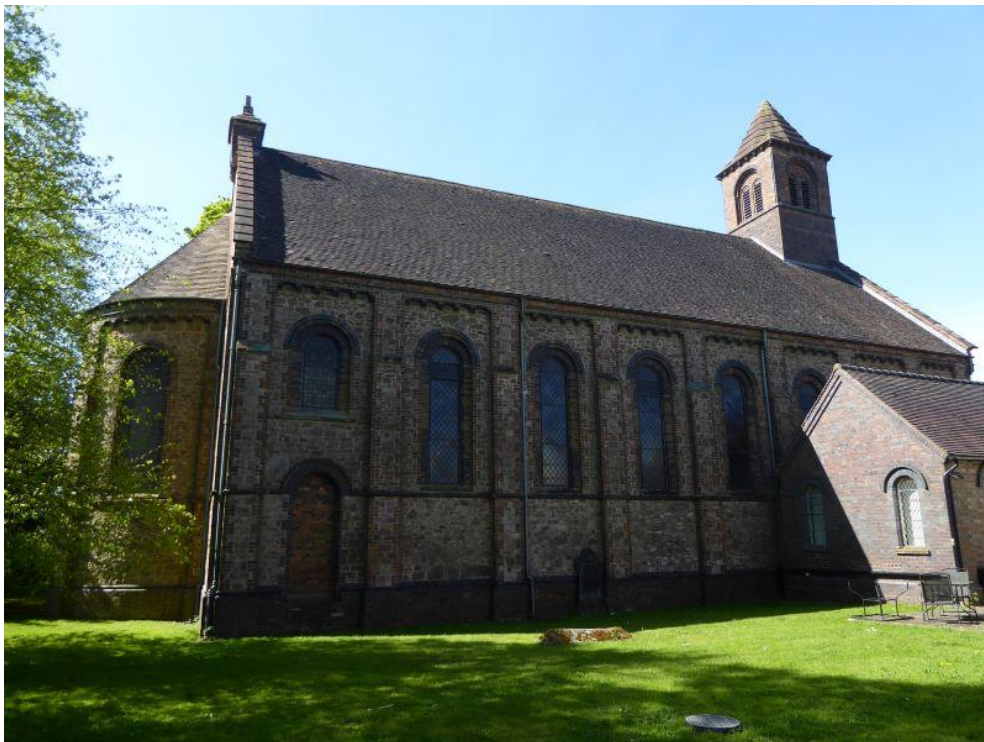
The Church interior is large and functional with a very wide Nave with no pillars.

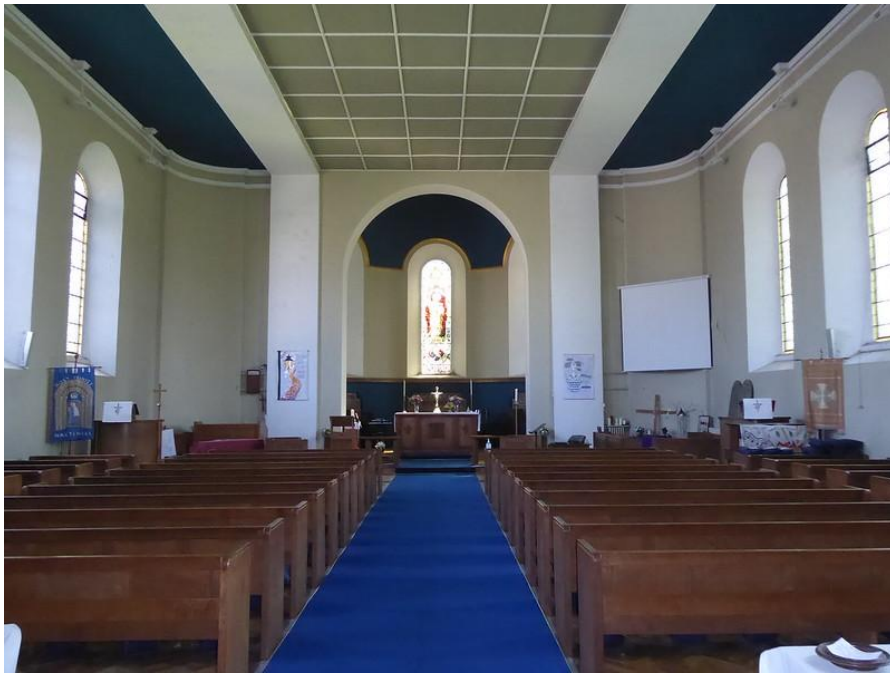
At the western end there is a gallery which originally had seating which contributed to the capacity of the church. On the front part of the gallery the seating is still in place. A partition separates the front part of the gallery from an area in front of the large Rose window. This sealed off area also has some of the original steps (but not the seats). The organ pipes are centrally placed and are a prominent feature.

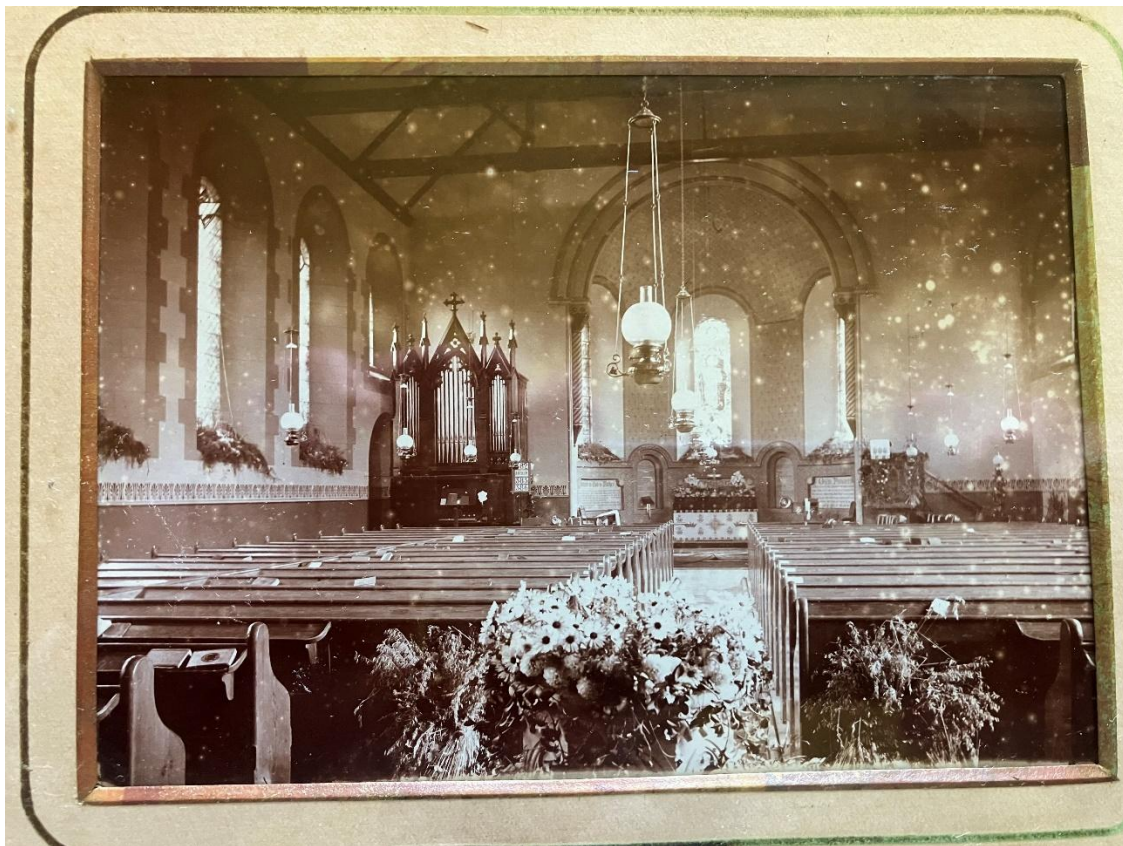
There are some old photographs stored in the Church which showed the interior as it looked when built in 1848. One of the clearer photographs dated 1913 is titled 'Holy Trinity in the days of oil lamps.'

There is also a floor plan which showed the original layout and position of pews. Interestingly the font was in the central aisle soon after entering the church. There is now a stone octagonal Gothic style font in the Southwest corner of the Nave. This could well be the original font.

All the original pews were of white pine. Some of the centre seats had panels as they were rented seats. The roof space was open, supported by heavy beams from which hung chains with the paraffin lamps and their ruby-glass vessels. In the northeast corner stood a pipe organ. Choir stalls were of a bench type.

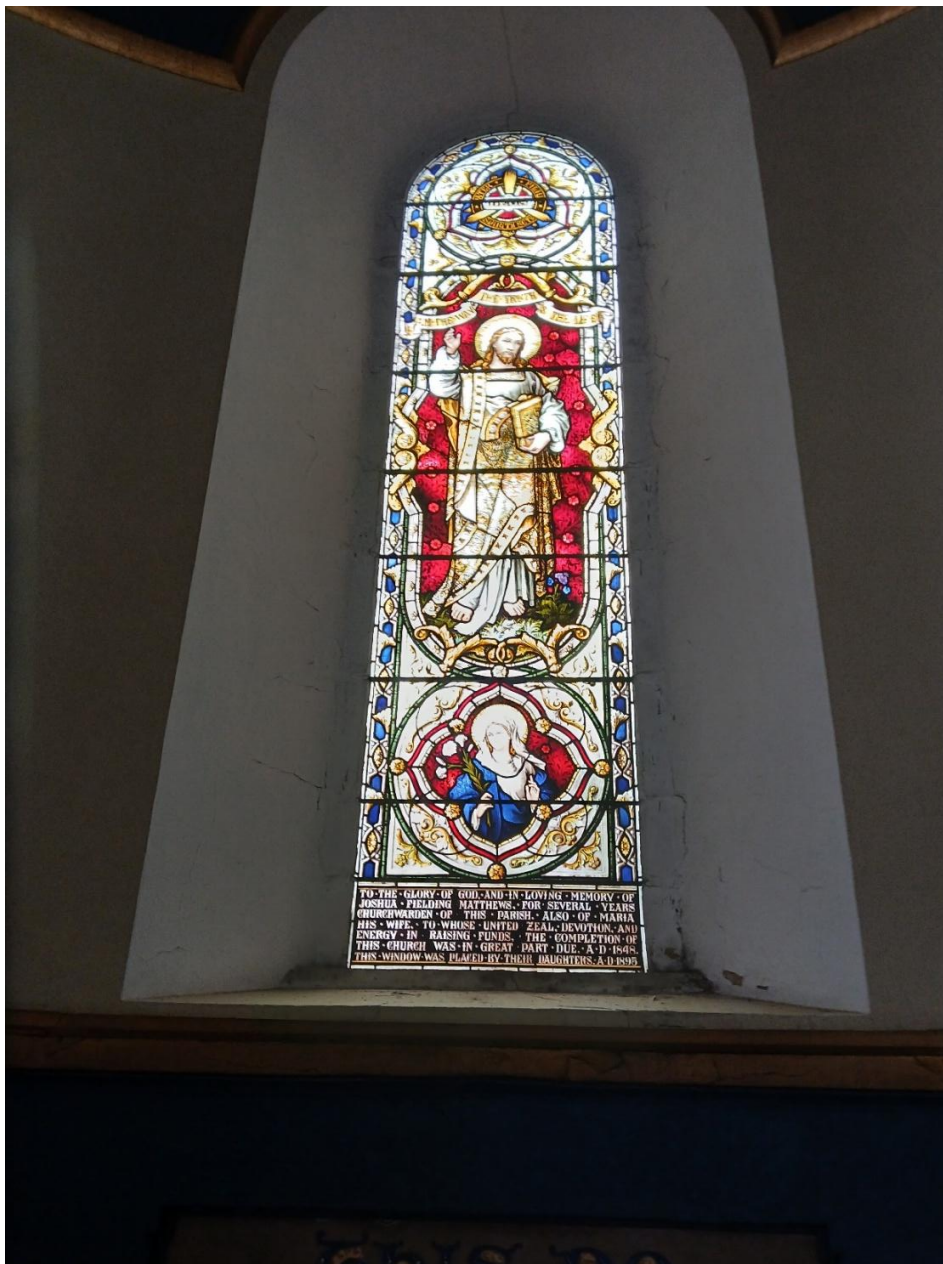
Central Window- This was installed in the middle window in 1895 in memory of Joshua Fielding Matthews and his wife Maria and was given by their two daughters. The figure is Christ.

The apse contains the three beautiful, stained-glass windows referred to in section 5. Nick Bayliss (Architectural Glass Ltd) who was consulted on the leaded windows in the north and south elevations, identified these 3 windows as Hardman's windows. There is the name of Hardman in small print on the north window (St Agnes).

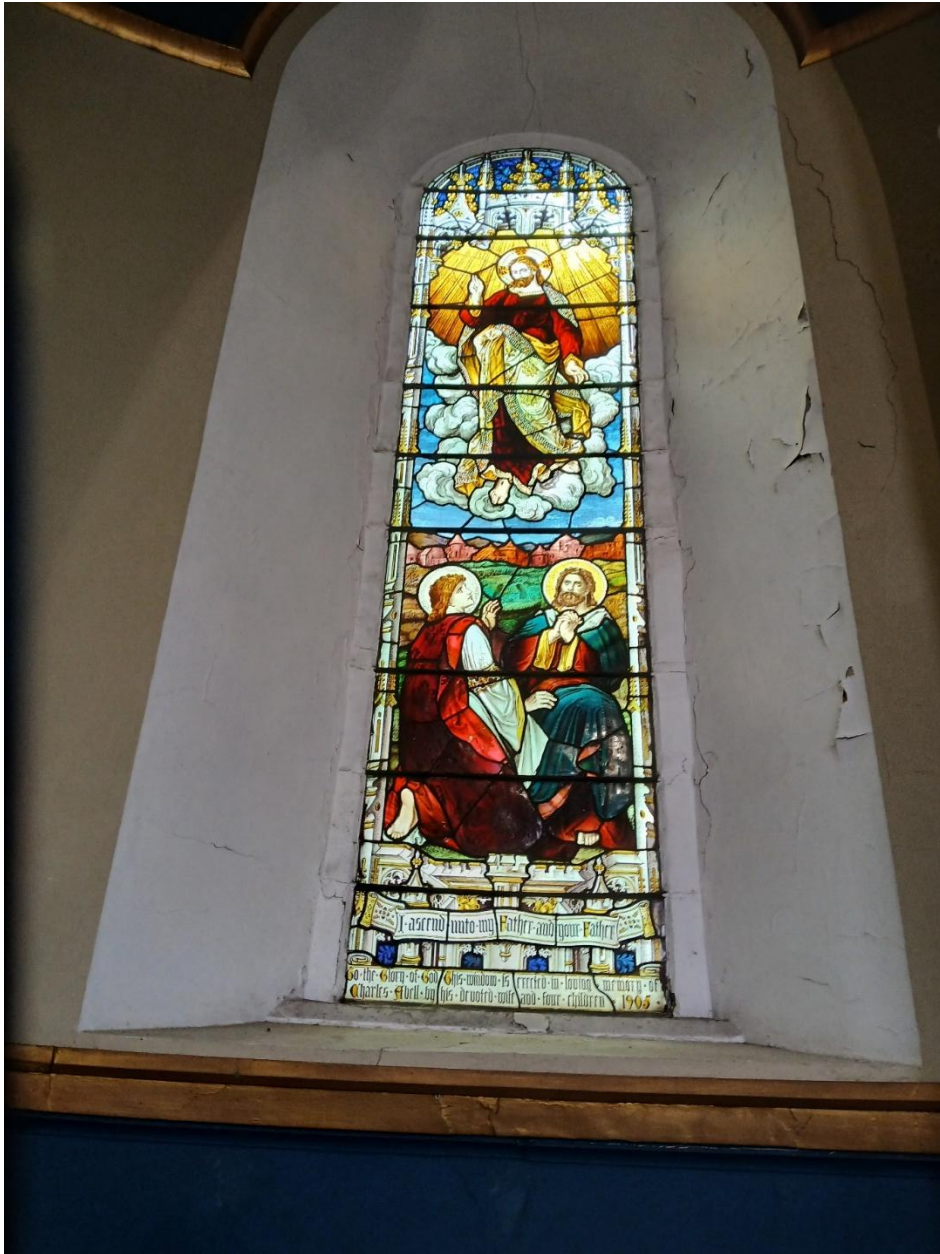
South Window installed in 1905 in memory of Charles Abel and was given by his widow and four children. The window depicts Christ ascending into Heaven.

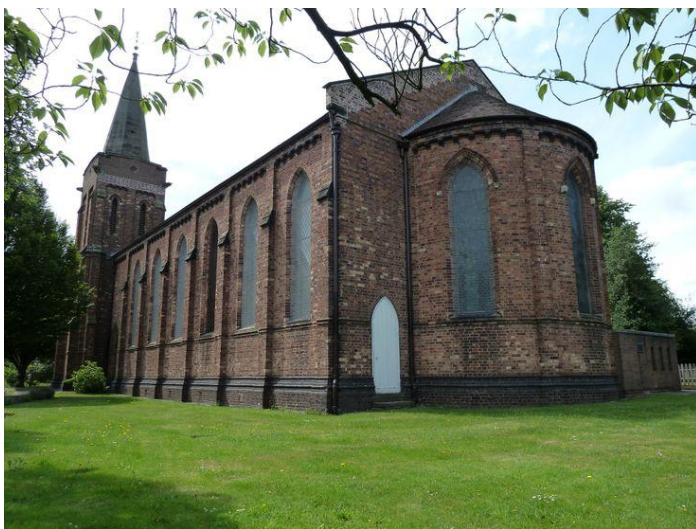
Holy Trinity Church,
Attleborough.

The side and rear elevations are so similar- see photo on page 12.
